The South African Civil Aviation Authority
Aircraft Accident Investigation
Final Report

Cessna S550 (ZS-CAR)
George Aerodrome (FAGG) January 23, 2020

AIID Ref No: CA18/2/3/9855
November, 2021

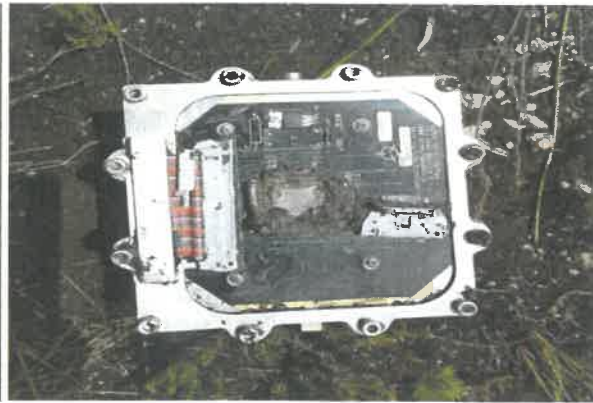
Figure 8: ZS-CAR - Recorder opening & read-out - BEA - 3rd Feb 2020

The FDR was visually examined. The chassis was missing, and only the FCSSU was brought to BEA. The PCB card was damaged and the FCSSU seemed compressed. The connector was dirty and the plastic package was broken.

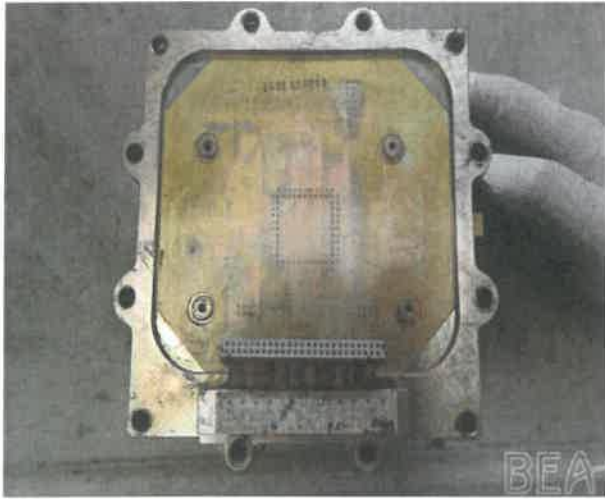
The FCSSU was opened. The main electronic board was extracted. It was in good condition. Inside the FCSSU, the electrical flat ribbon seemed in good condition. It was decided to perform a first electrical check with the connector of the event.

Figure 9: FCSSU Internal Check

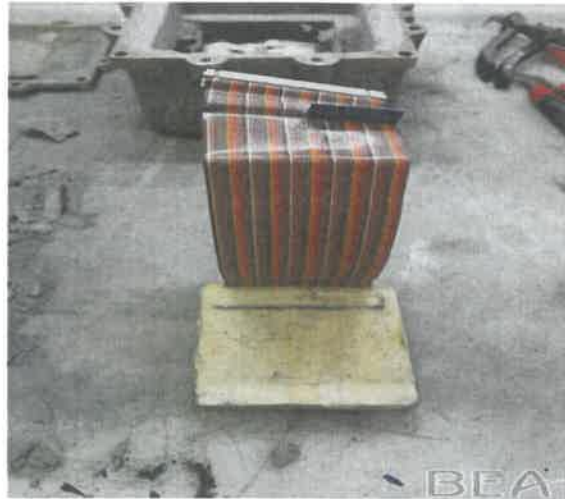
Figure 10: Electrical Flat Ribbon

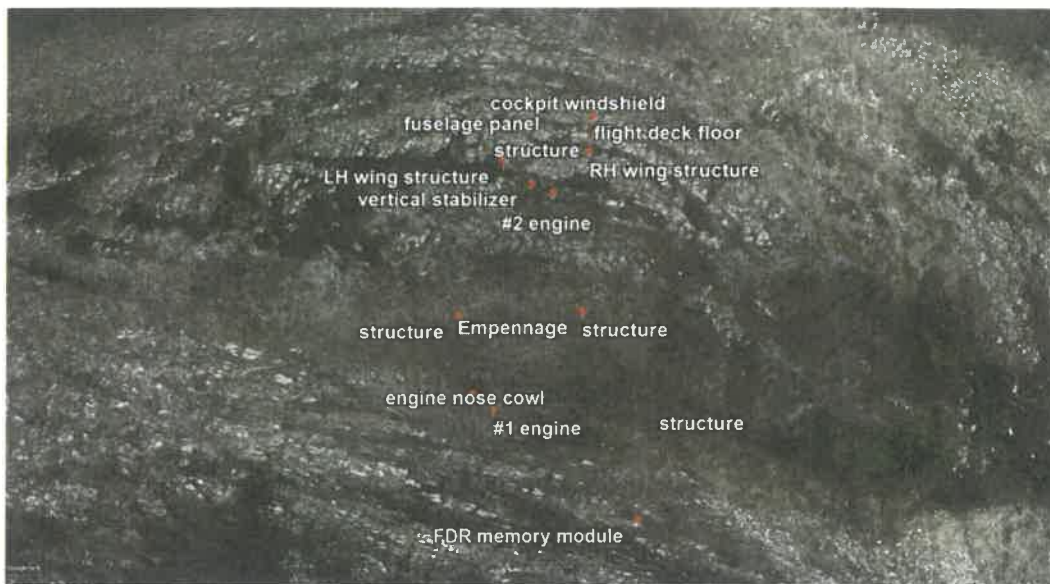
Figure 11: The Layout of the Main Aircraft Components Field. (Source: Google Earth)

According to the available FDR graph plot, the aircraft impacted the terrain at an indicated airspeed of approximately 286 knots. Figure-11 indicates the position of all main components found at the accident site.

The Investigators group, assessing the accident site divided the accident debris field into three zones. The first zone spans from the point of initial impact to 90m, the second zone from 90m to 180m, and the third zone from 180m to 270m.

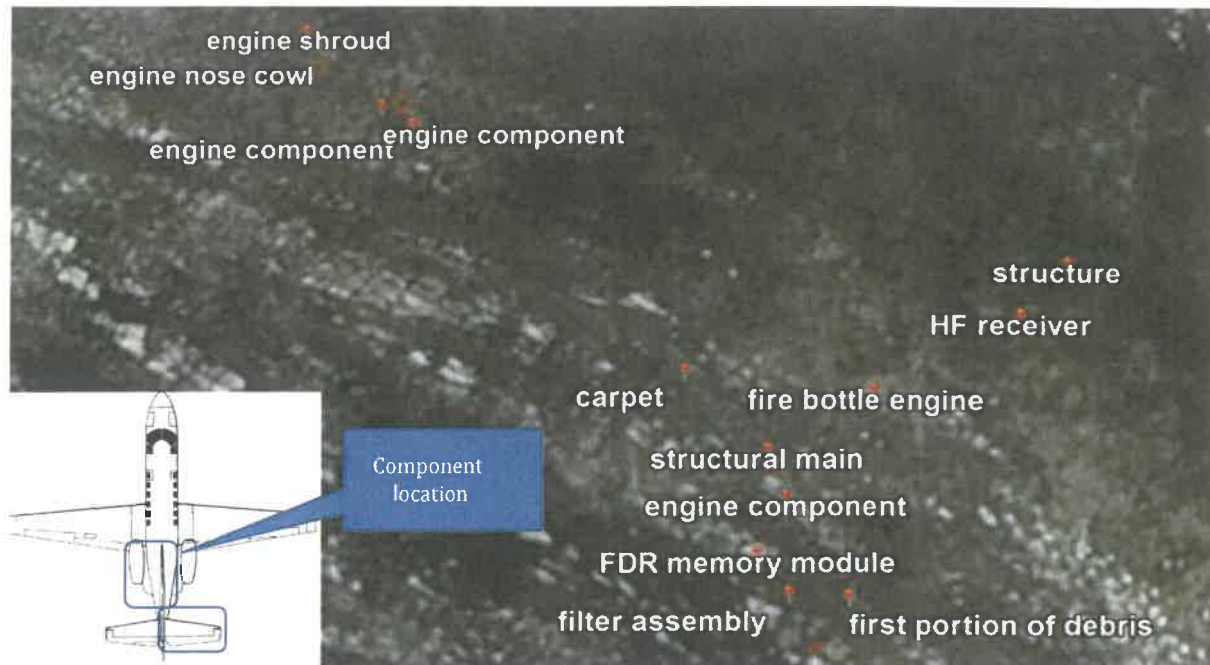
Debris in this zone consisted of empennage-related items such as the engine fire extinguisher bottles, the FDR and the high frequency (HF) receiver. The first portion of the rear cabin interior was found approximately 35m from the point of initial impact.

The upper left portion of this zone includes debris from engine No 1 nose cowl, shroud and piping.

Figure 12: First Spread of Debris. (Source: Google Earth)

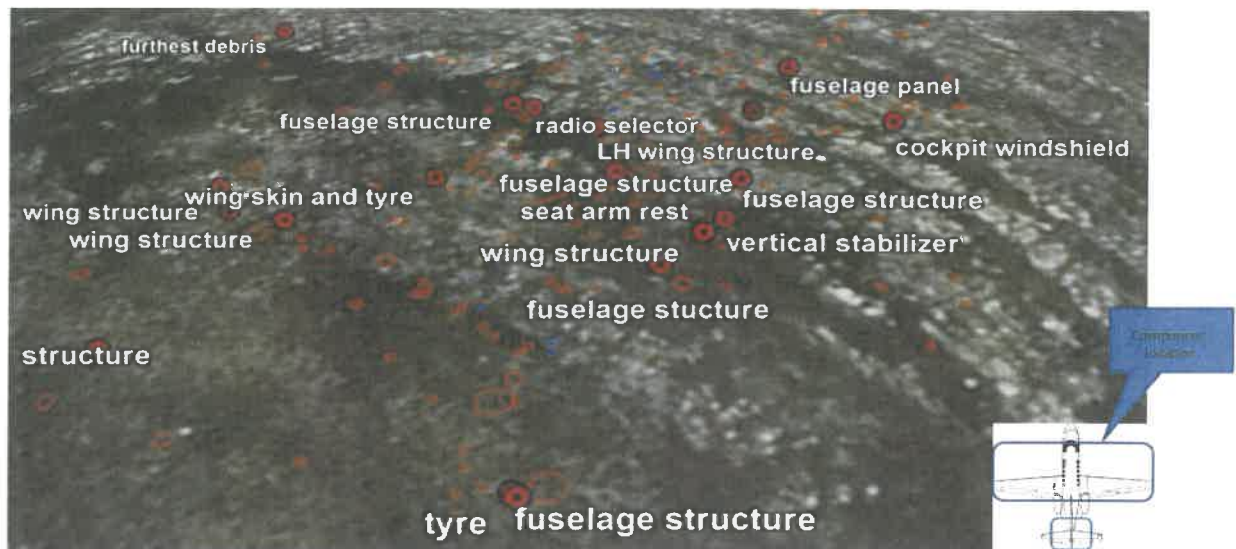
This portion of the debris field formed the main area of debris spread and consisted largely of the fuselage and wing structure. Cabin items such as arm rests and carpets were also located in this area. The left wing remained largely intact and the right wing had severe damage and was highly fragmented. The left-hand elevator was destroyed, and the vertical stabilizer came to rest approximately 125m from the initial point of impact. This portion of debris experienced post-impact fire damage.

Figure 13: Second spread of debris. (Source: Google Earth)

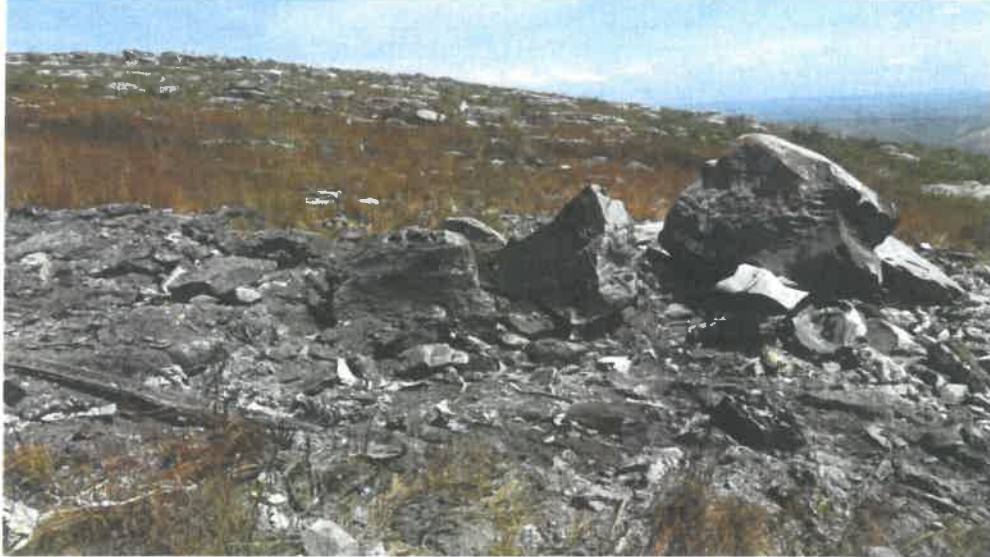
The aircraft sustained a post-impact fire.

Figure 14: The Close-Up View of the Red Circled Area in Figure 14 below

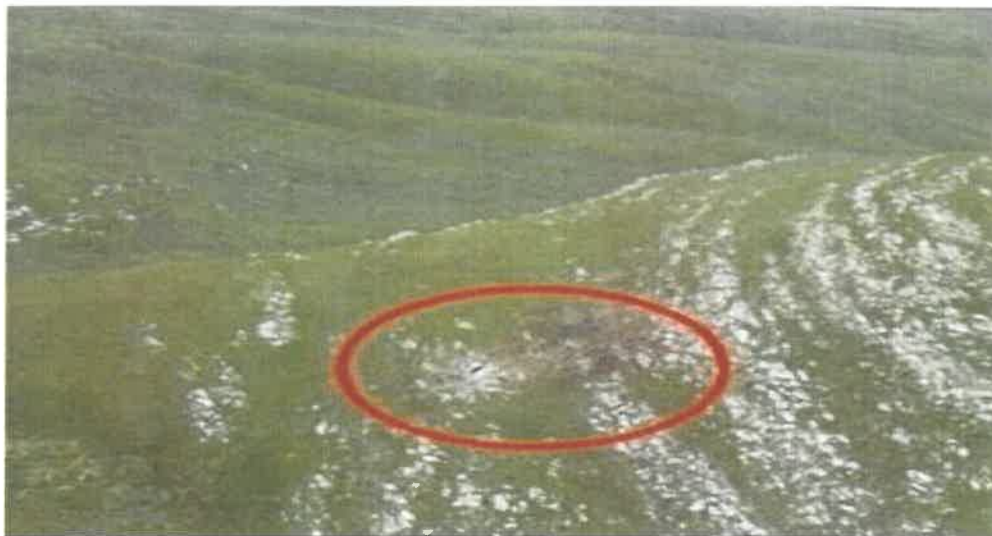
Figure 15: The Red Circle Indicates the Fire Damage on the Surrounding Vegetation.

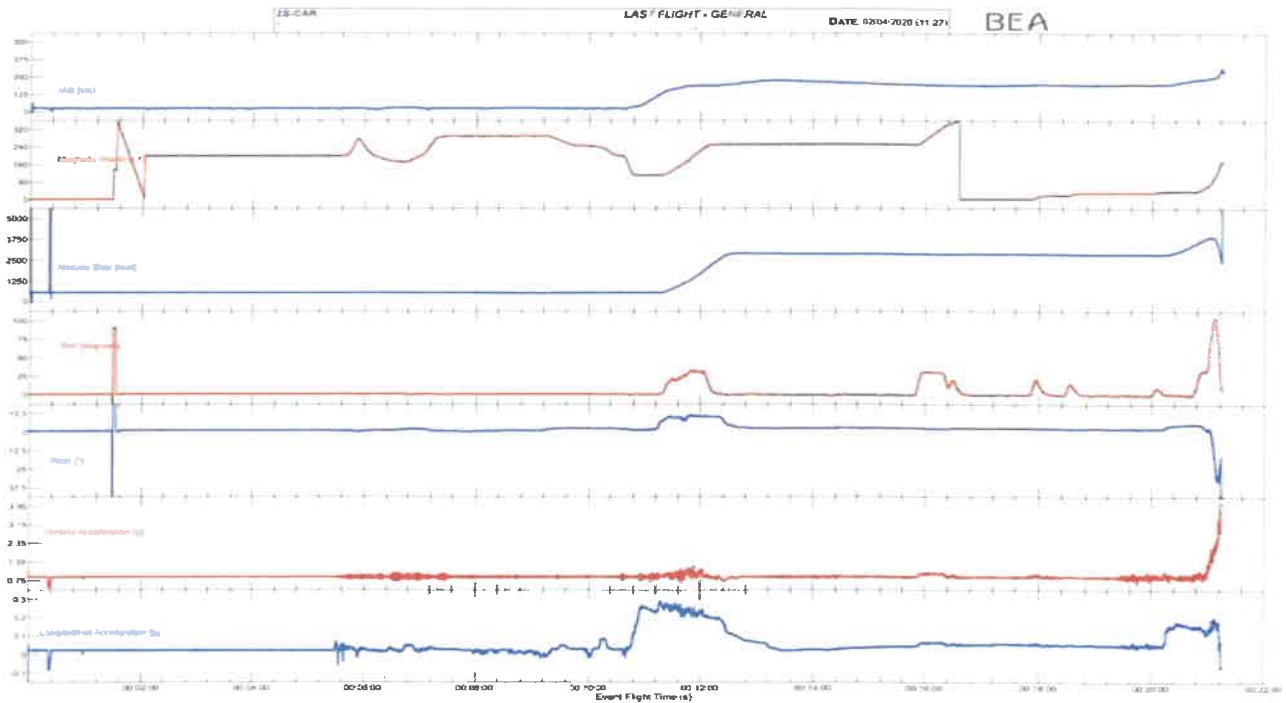
Figure 16: General View of the FDR Analysis

In the first phase of flight the aircraft pitch decreased from 5⁰ degrees to two degrees with an increase of its speed to 245kts at the same time the altitude increased from 2900ft to 3900ft. In this phase the aircraft roll was about zero degree but immediately it began to deviate to 35⁰degrees even if the aircraft magnetic heading was constant (37.5⁰) at about 00:20:45 it changed to nearly double of the first heading which is plotted on the graph.

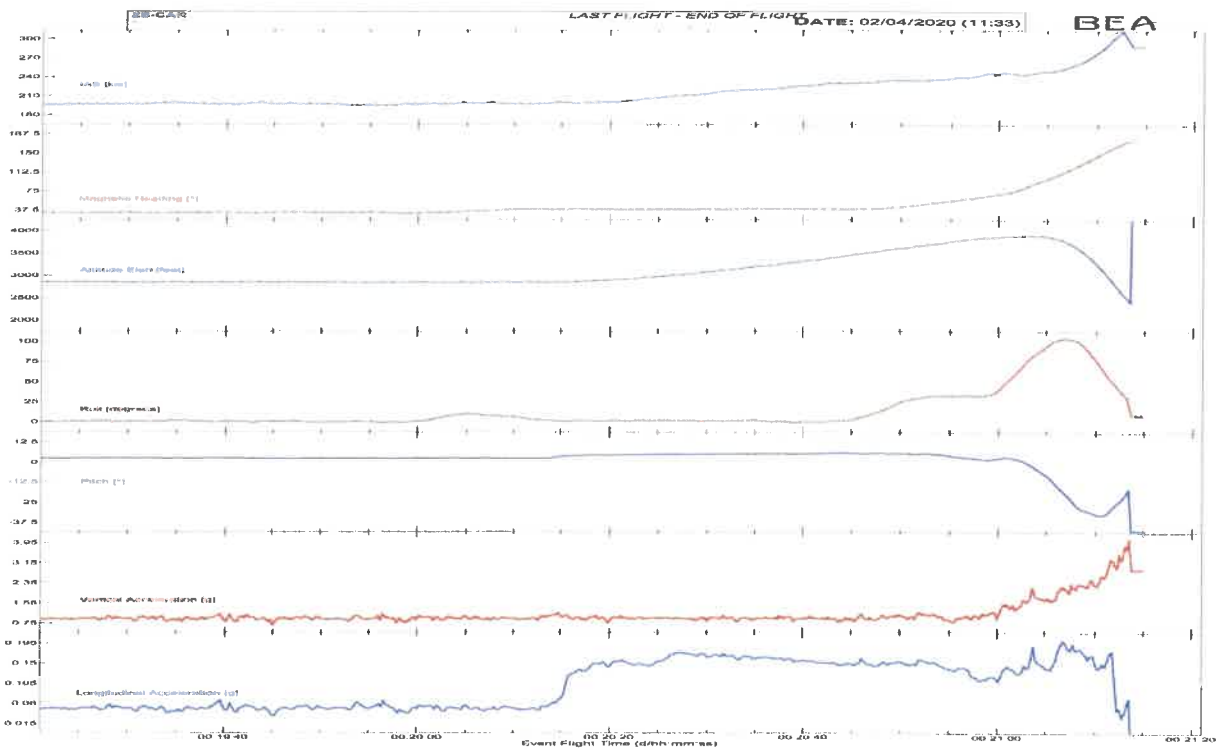
Figure 17: Last Event Flight

In the second phase of flight the aircraft was flying with nose down to -32.5 degrees decreasing its altitude to 3200ft and 2800ft. The aircraft heading changed to 150degrees and its roll to 105 degrees which was overbanked and immediately changed to 75⁰; which can't be determined why the roll of the aircraft suddenly changed from 35 to 105 degrees and then to 75⁰.
