SUPPLEMENTARY FOUNDING AFFIDAVIT:

ETHEKWINI WATER & SANITATION
SANITATION OPERATIONS ACTION PLAN
STORM DAMAGES

**INVESTIGATION, DESIGN, &
SUPERVISION FOR STORM
DAMAGE OVER A PERIOD OF 36
MONTHS. (GLENWOOD ROAD
WWTW AND CATCHMENT).**

FLOOD DAMAGE REHABILITATION, REFURBISHMENT & UPGRADE OF THE UMBILO WASTEWATER TREATMENT WORKS – TECHNICAL ASSESSMENT REPORT

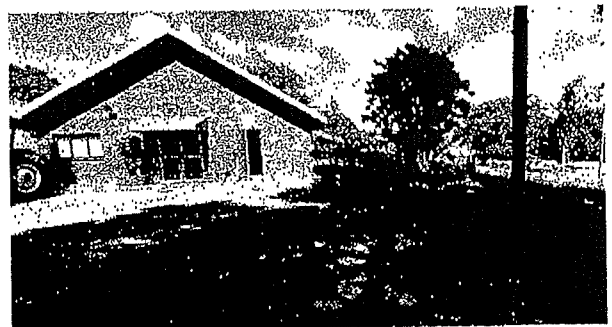
3.2 Administration Building

Status: Minimal flood damages

Remedial action: General maintenance required, i.e. lighting, air-conditioning etc.

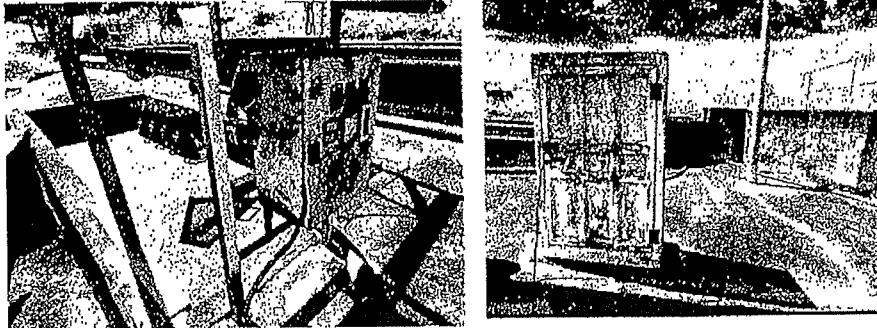
3.5 De-gritter

Status: Electrical supply panel and remote stop/start panel submerged during flood. Damage to panels are evident.

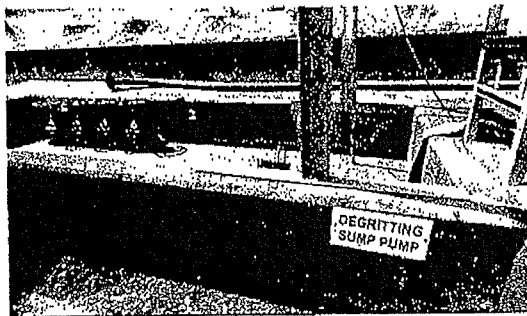
3.6 De-gritter sump pump

Status: Pump submerged, unable to assess.

Remedial action: Pump to be assessed by specialist and applicable repairs undertaken, Pump to be repaired if unsuitable.

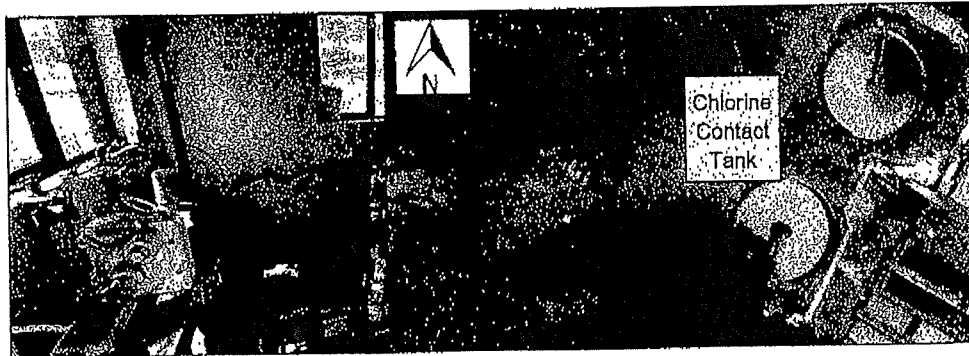
3.16 Chlorination

Status: Chlorine equipment is operational however refurbishment and maintenance of the dosing equipment is recommended considering the existing condition.
