The South African Civil Aviation Authority
Aircraft Accident Investigation
Final Report

Cessna S550 (ZS-CAR)
George Aerodrome (FAGG) January 23, 2020

AIID Ref No: CA18/2/3/9855
November, 2021

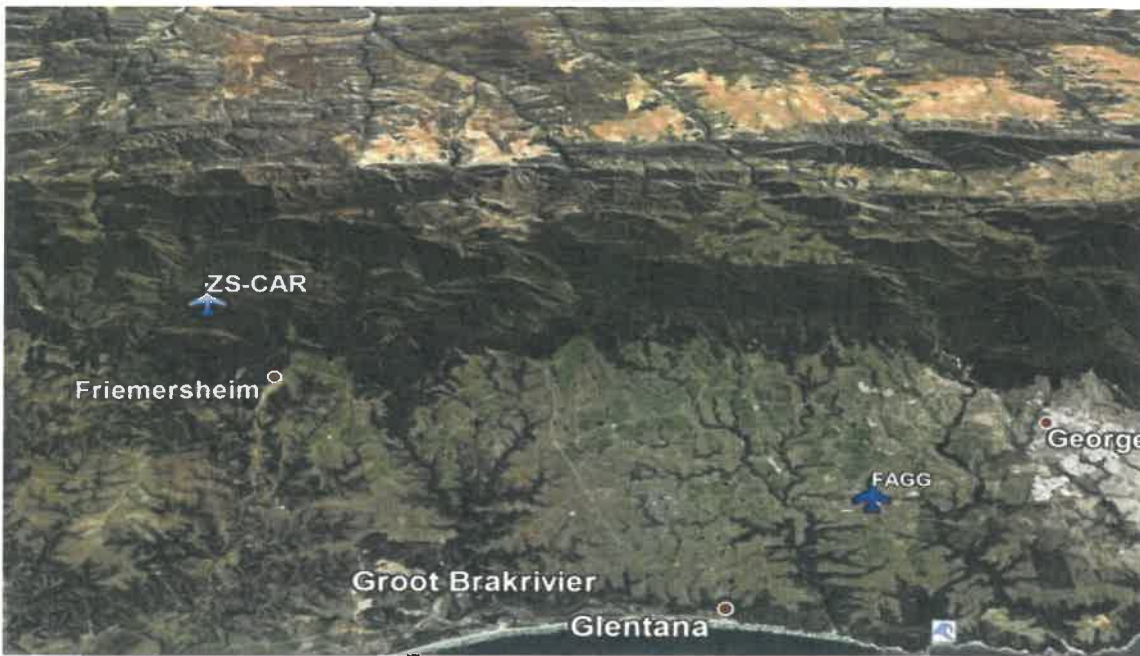
Figure 2: The wreckage was located north of Friemersheim in the Western Cape. (Source: Google Earth)

The crash site found at the top of the Outeniqua mountains, near the town of Friemersheim, at Global Positioning System (GPS) co-ordinates 33°55'24" South 022°06'30" East, at an elevation of 2192ft. The aircraft was found destroyed on impact and all occupants were fatally injured.

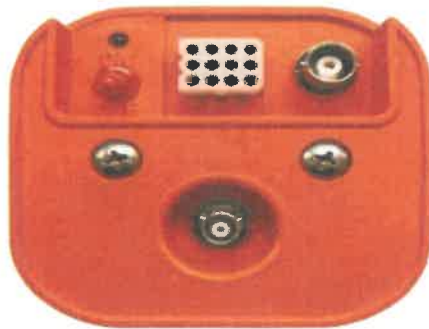
FIGURE 3: ELT ARTEX C406-2

The aircraft was fixed with an Emergency Locator Transmitter (ELT) with the description ARTEX ELT C406-2 with part number 453-5000 and serial number 170-07269. The ELT did not transmit a signal following the accident, and it was not found at the accident site. The ELT was last bench-checked on 28 May 2019 and its battery changed on 2 October 2019.

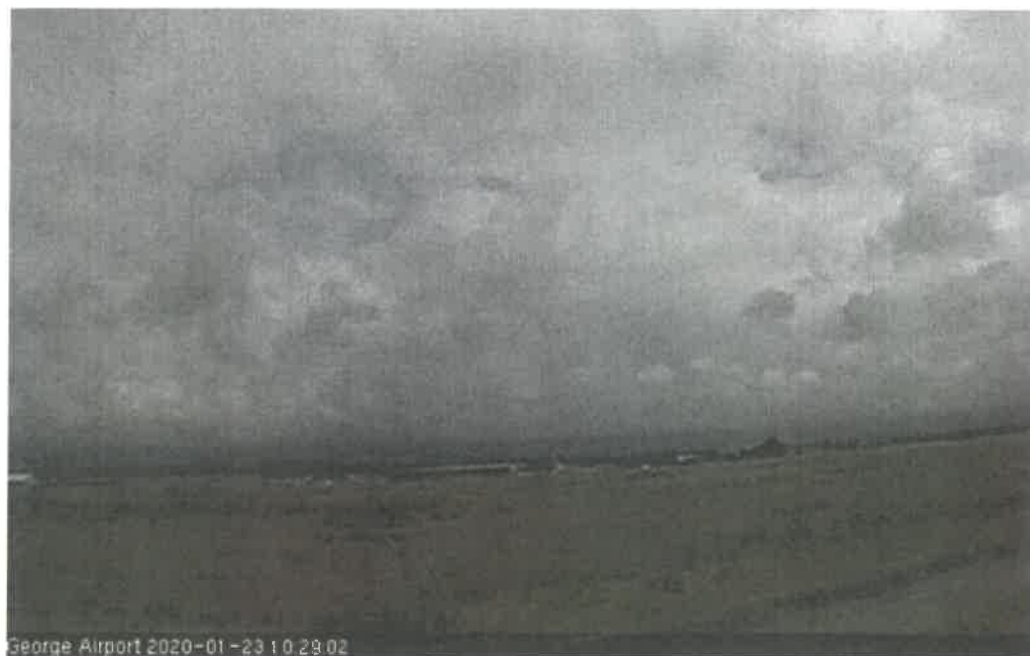
Figure 5: A Webcam Observation at 0829z in the morning of the accident at FAGG. (Source: SAWS)

According to the SAWS report “Significant clouds below 1,500ft above ground level (AGL) were present at the time of the accident as observed in the METARs. There was no indication of drastic wind direction or speed changes as seen on the spot graph. Mountain tops were obscured as seen on the webcam.” Refer to Figure 5. Furthermore, no low-level turbulence was forecasted or observed in the area.
